# Manhole Inspection Summary

Manhole # S21II\_054MH

**Inspection** ☐ Is Incomplete Rating: **3) Fair**

**Location** Address: **1812 MCKEAN AVE**

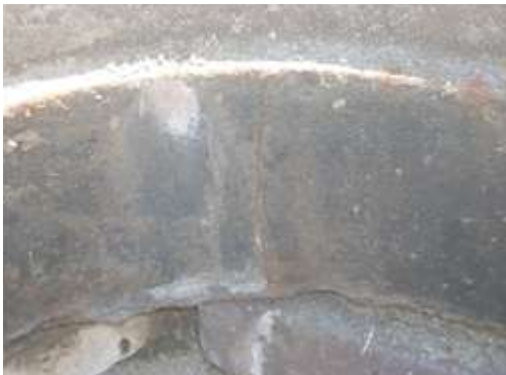
Defect 4

Condition: ☐ Sound ☒ **Cracked** ☐ Leaks

CRACKED FRAME

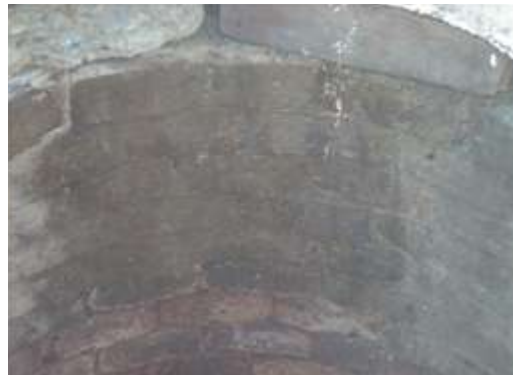
Defect 3

Infiltration: ☐ None ☐ Joint ☐ Cracks ☐ Mortar ☐ Roots ☒ **Wall**

INFILTRATION OF CHIMNEY

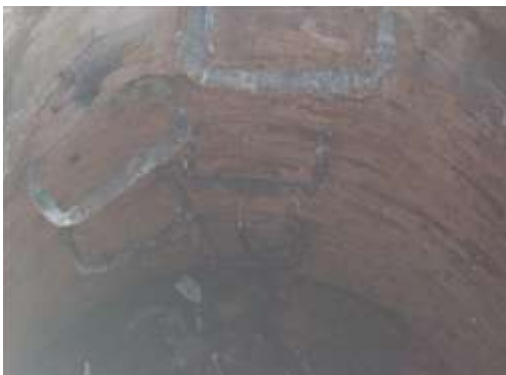
Defect 2

Count: **5** Missing: **0** ☒ **Corroded**

CORRODED STEPS

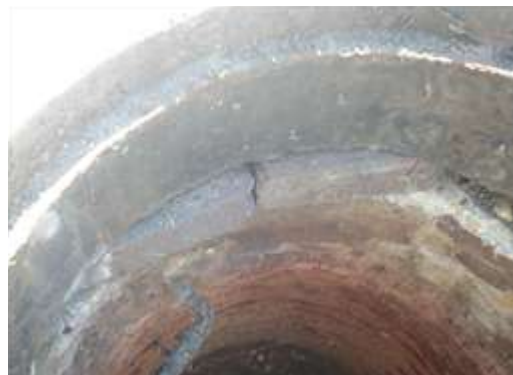
Defect 1

Condition: ☐ Sound ☐ Cracked ☐ Root Intrusion ☒ **Loose Brick** ☒ **Deteriorated**

LOOSE CHIMNEY BRICKS

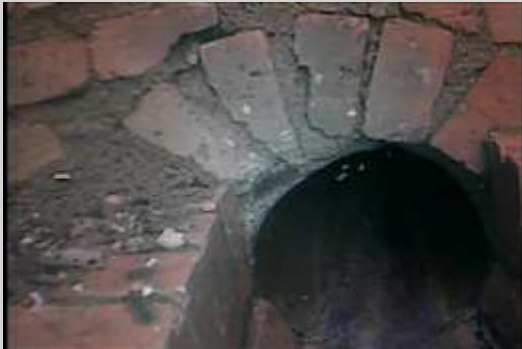
12 O'Clock Outflow

Pipe Height: **8.4** (in.) Rod and Bar (Angled)  
Pipe Material: **Clay** ☐ Pipe Lined  
Invert Depth: **10.10** (ft.) Flow Characteristics: **Fast**  
Deposits: ☒ None ☐ Mud ☐ Sludge ☐ Debris ☐ Grease  
Silt Depth: (in.) Deposits Extent:  
Infiltration: **None** Pipe Seal Cond: **Sound**

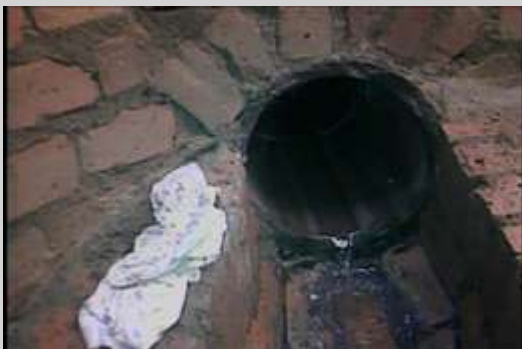
3 O'Clock Inflow

Pipe Height: **8.4** (in.) Rod and Bar (Angled)  
Pipe Material: **Clay** ☐ Pipe Lined  
Invert Depth: **9.39** (ft.) Flow Characteristics: **Slow**  
Deposits: ☒ None ☐ Mud ☐ Sludge ☐ Debris ☐ Grease  
Silt Depth: (in.) Deposits Extent:  
Infiltration: **None** Pipe Seal Cond: **Sound**

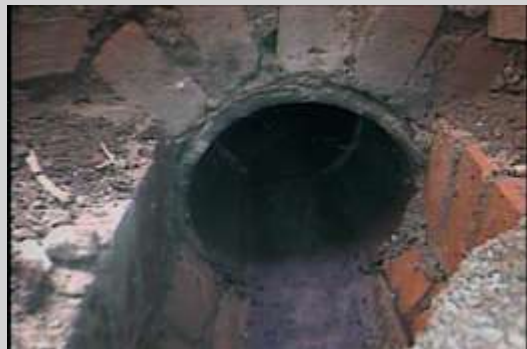
6 O'Clock Inflow

Infiltration: **None** Pipe Seal Cond: **Sound**
